Tip of the Month – October 2023

Clean teat liners.

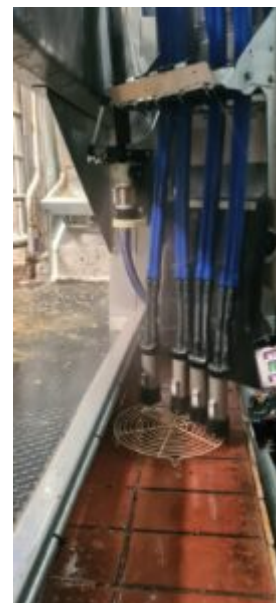
When the milking robot is on a flat floor and there is no pit for it, for example, it sometimes happens that during the back-flush, which is the rinse after each milking, the teat cups, or actually teat liners, touch the ground.

That place cannot always be kept clean all day and night, so it is not very hygienic.

A solution is to put something simple here that ensures that the teat cups do not touch the ground and that is easy to keep clean.
